## JUST WHEN YOU THINK YOU'VE SEEN IT ALL

Microwave path failure at it's finest

By Gary A. Minker

June, 2017

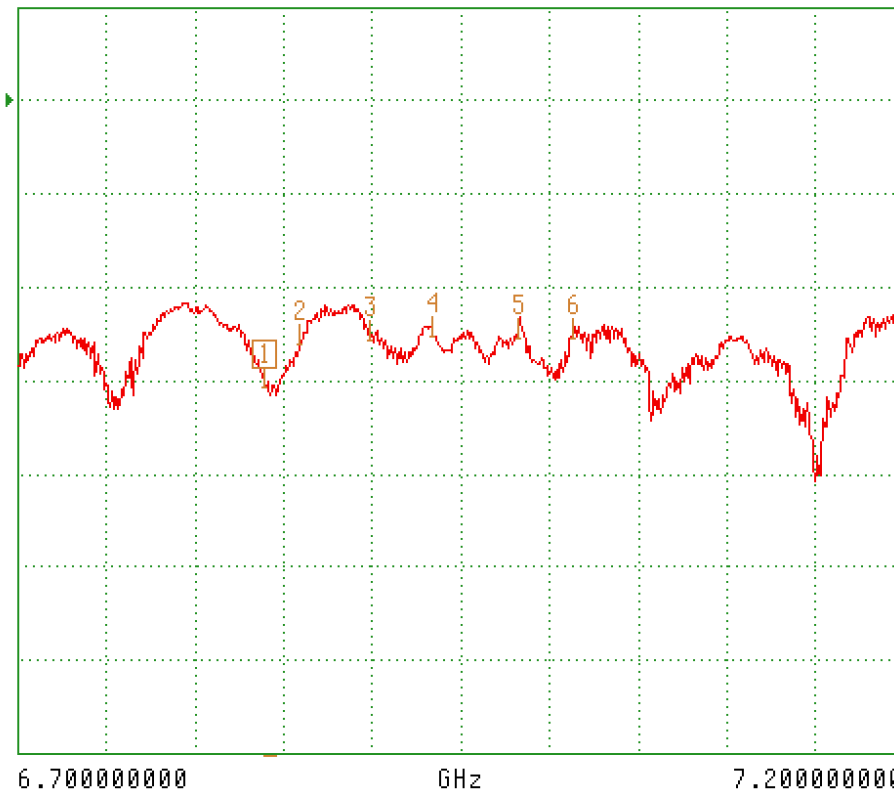
FIGURE 1:

The first dance in to the system with the Vector Network Analyzer, the right fittings and all the cool toys shows a nominal high 20 something dBm Return Loss with a nearly perfect Time Domain. (See figure 1 and 2) This data is largely normal with the only fly in the ointment being a suspicious input connection to the dish that presents at -26dBm. This conclusion was arrived at with a full line characterization with a short and termination.

Ordinarily with new work, I would fail the system with such a connection value but this is certainly not new work, fatal, nor the big stinky cheese. In conferring with the Magna cum Laude guys on the tower, the radome is not in too bad of condition and the over all Time Domain of the four planes of the dish seem pretty good since I can indeed make out the input, the aperture of the feed, the parabola and the radome.

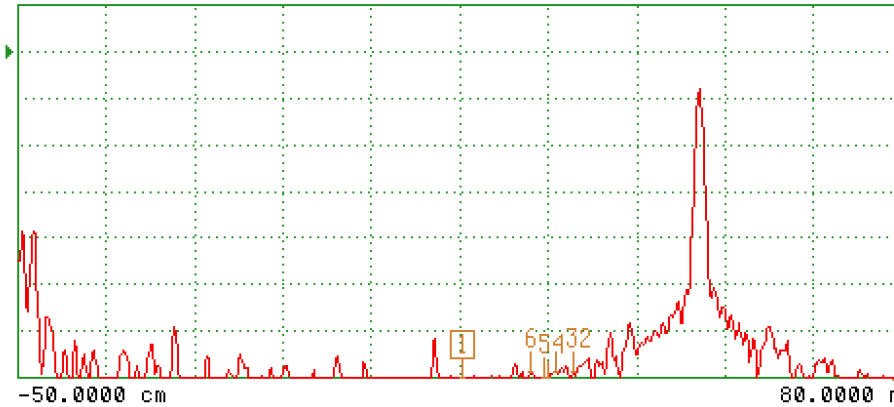
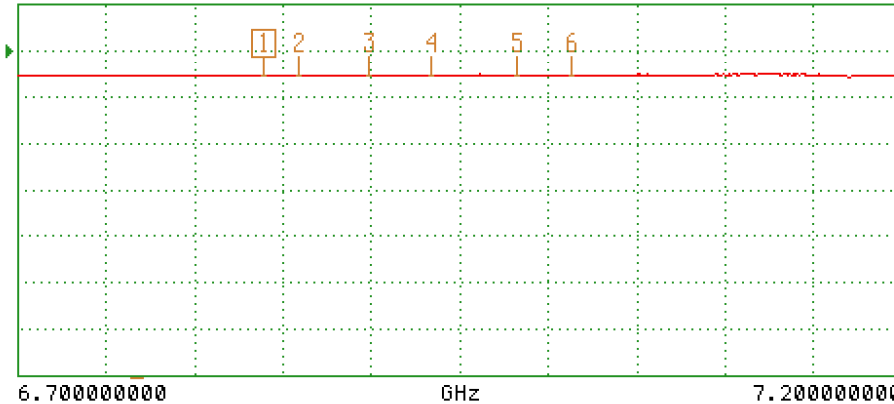
FIGURE 3:

The first pop up of trace data just happened to be a dual overlay of a split screen with Time Domain on the top half of the screen and the Return Loss on the bottom half of the screen. The frequency spread of the calibration is well within the range of the feed horn and the scary spike at the end of the Time Domain in concert with the 4dB Return Loss on the bottom half all spell only one thing. The antenna is "electrically" missing. While the system is still holding pressure and the dish is certainly still physically up there,,, the thing is just not home. If the line were open or the connector ripped off, the system would not hold pressure, the hop would be down and the Return Loss would be closer to -12dBm with an open air coupling to the ether.

Up the tower goes the replacement feed horn. After nearly a hour of trying to snap corroded hardware and 2 cans of Kroil, the old feed was out and the replacement was installed. In the words of Gomer Pile, shazam and goolllee, the result on the analyzer was sheer joy. (see figure 3) This data trace is a live look at the broken feed horn.

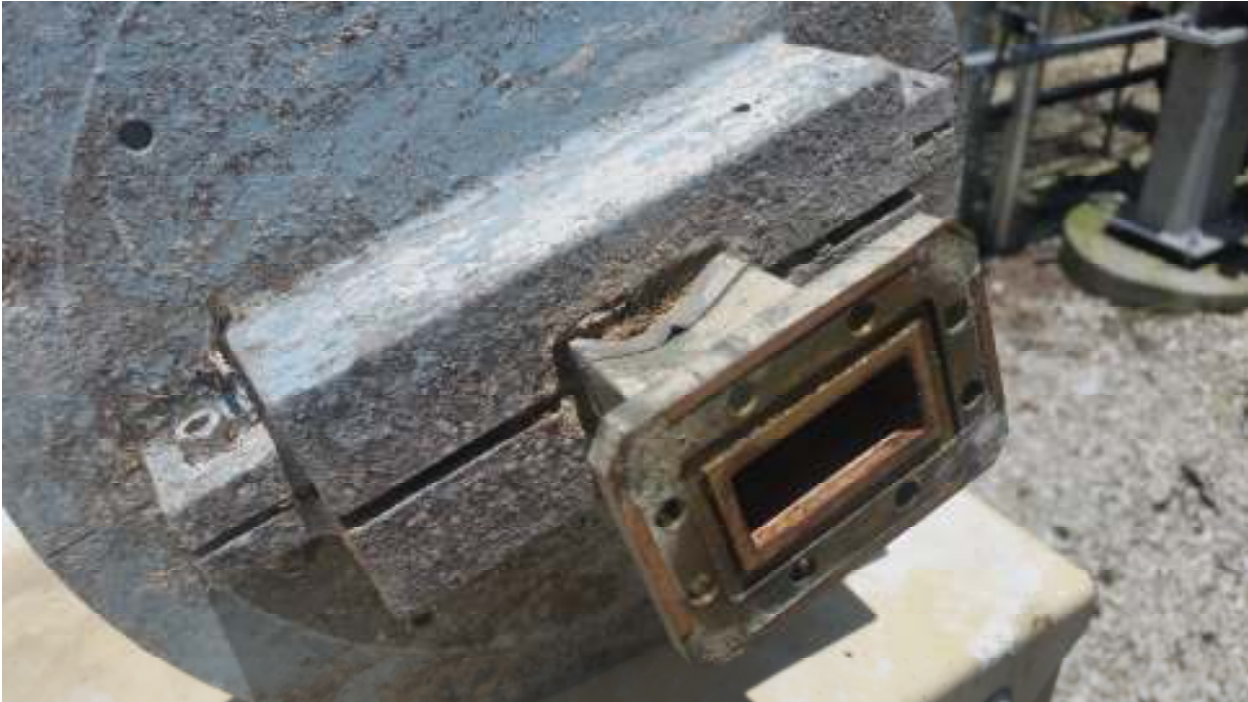
FIGURE 4:

Looking backward at both sites, the obvious mode of failure found at the second site is the precursor to the start of the failure found at the first site. Figure 4 shows you what an old dish in the salt marsh can do if left with no maintenance and inspection people who do not know what they are looking at. The rigid copper feed guide of the button hook is completely crushed to the point of internal contact by the corroding pot metal of the aluminum casting of the polarizing flange. The growing crystal corrosion of the flange is not only splitting the massive reinforced casting apart and stretching the clamp hardware, it totally crushed the E plane walls of the rigid waveguide. Figure 5 shows an internal view of the rigid waveguide where the wall sides are actually touching.

Even with this incredible damage, and a Return Loss of only -4dB, the system was still on the air, albeit with a near zero fade margin. Examples like this stress the value of having competent and trained personnel with realistic technology and tools at their disposal. While mechanical inspection are super important, bringing in your Line Sweeper WITH the tower crew can often ward off Cousin Murph and his bag of evil spirits. No matter if the system is just a hop from pop to pop, or a critical remote Public Safety link, unless you don't mind egg on your face or being stood up in front of the firing squad, proper testing and inspections are the key to longer life of your system. After 38 years, I am pleased to learn a new trick.
