# DOUBLY INTERMITTENT

GARY A. MINKER

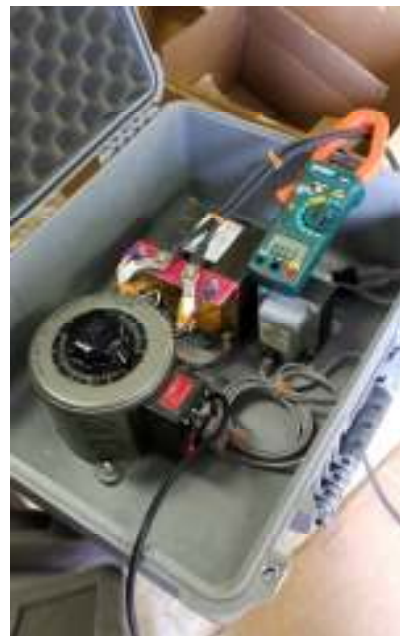
We make the decision to bring down the upper three bays to inspect and clean them. Bay three has a bit of arc soot on the bullets but it is easily cleaned and has continuity between all of the inner conductor parts. To insure that we did not just have the word of some flaky faced digital Ohm meter, I brought out my specialty tester that I affectionately call "Mr. Burner". This variable, isolated, low voltage source can deliver up to 50 Amperes of current to test for bad connections, bullets and weak watch band springs. We employed Mr. Burner for all of our continuity testing and looked for a solid five to ten short duration Amps to indicate quality connections.

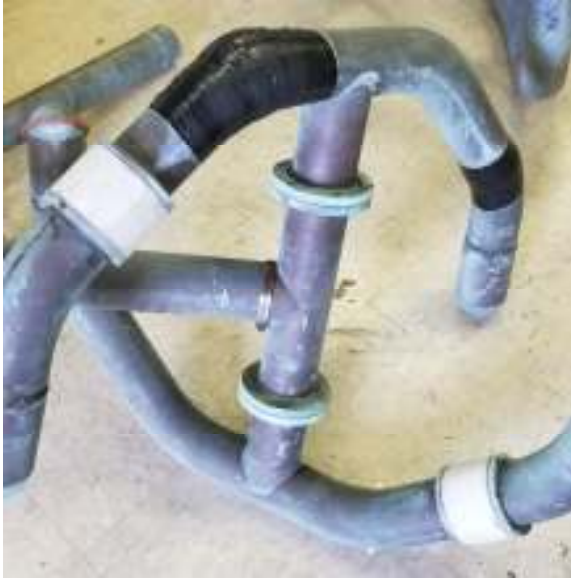
another case. Mr. Burner revealed that the shorted stub was indeed not viable. We removed the stub and tested it with the Burner, and of course the stub drew current perfectly. The test leads were moved to the top bullet of the bay one block and the test run again, No Joy. The Burner was applied to the arm ends of the bay and still again, No Joy. OK, this is just not funny. The bay passed the shorting wire R.F. Analyzer test but won't pass AC or DC. This bay had suffered a lightning strike that burned a few holes in the pressurized side of the system. The tire patches did a great job of sealing the air leaks, and for several years, the patch looked great, but at the same time, the main antenna seemed to lose coverage. The auxiliary at half

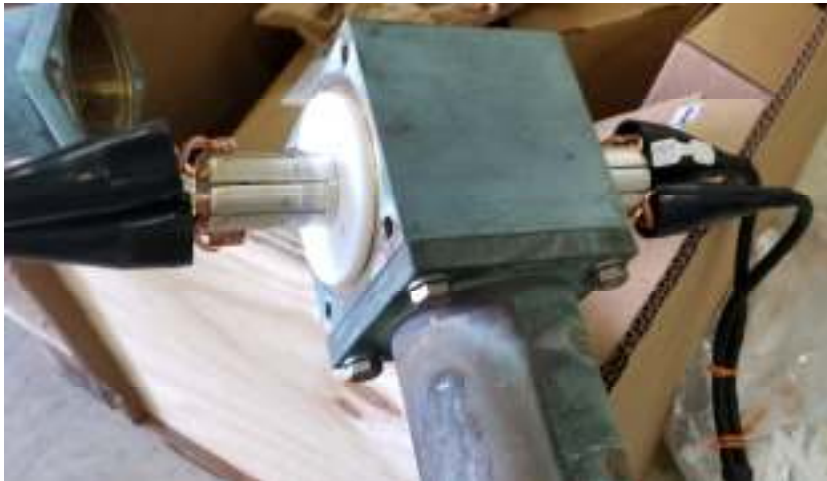
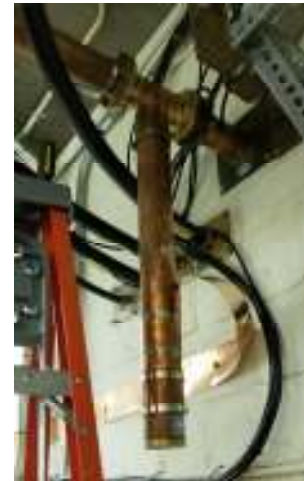
The new tuned short created some issues with the Line Sweeping. While it solved the static problem, no one put three and six together to realize the antenna was broken. Further testing with Mr. Burner brought us to the bay one block. The alligator clips were attached like a torture device and the continuity testing began. Up comes the Variac and with a hush on the crowd gathered, the Ammeter cried out NO JOY.

Alright, this is nuts. A bay connected to the block has no AC or DC continuity to the block on either bullet. Neither bullet has continuity to each other. The bay is clean inside or so it seemed.

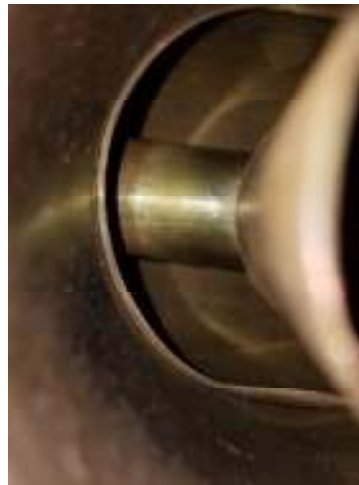
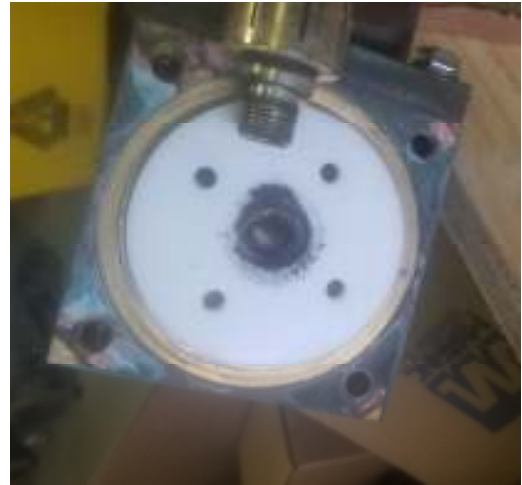
Soot. Look, soot. The bullets were removed from the bay inner block to find that both bullets were not properly torqued and they were both blowing arc soot out of their threads. The soot passed the R.F. testing and would not pass AC or DC.

Once the soot was brushed out of the inner TEE on both ends, and chemically cleaned. The freshly cleaned bullets and their dirty deeds were re-torqued and Mr. Burner applied his brute force.

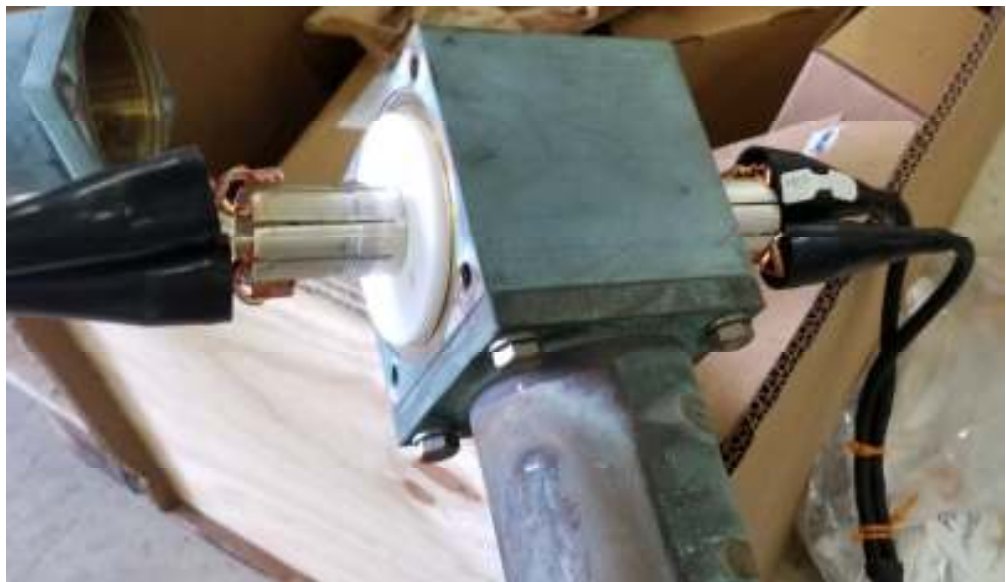
Finally we have conductivity from bullet to bullet and with the shorting stub attached, we had continuity from inner to ground.

All of the rest of the bays were brought to the ground for cleaning and continuity testing along with a right and proper torquing of the bullets.
