# Intermittant Fire Alarm

AN ARTICLE

GARY A. MINKER

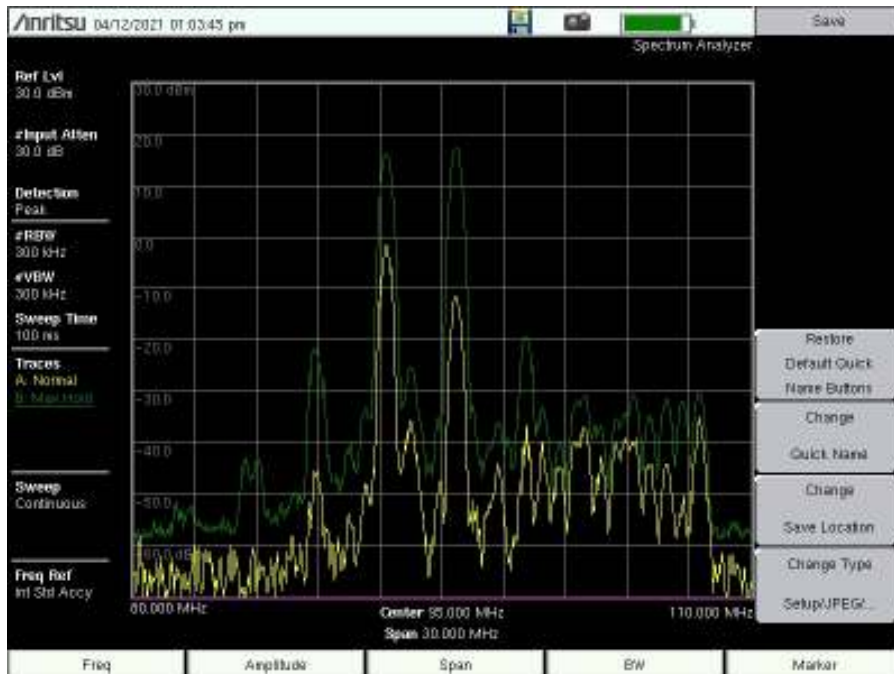
The peak hold energy readings of -23dBm were very impressive. Considering the loss value of the average Rubber Duckie, I could feel my belt buckle complaining while I walked around snapping samples all over the roof. Interestingly enough, the transmitter room which is on this same level and has a 14 inch thick concrete and mesh mat roof had a significantly lower R.F. level.

With the reading of radiated signal being 20 or more dB down from the readings directly outside, a bit of a wet rag was starting to form over the possibility that the new transmitters were the problem.

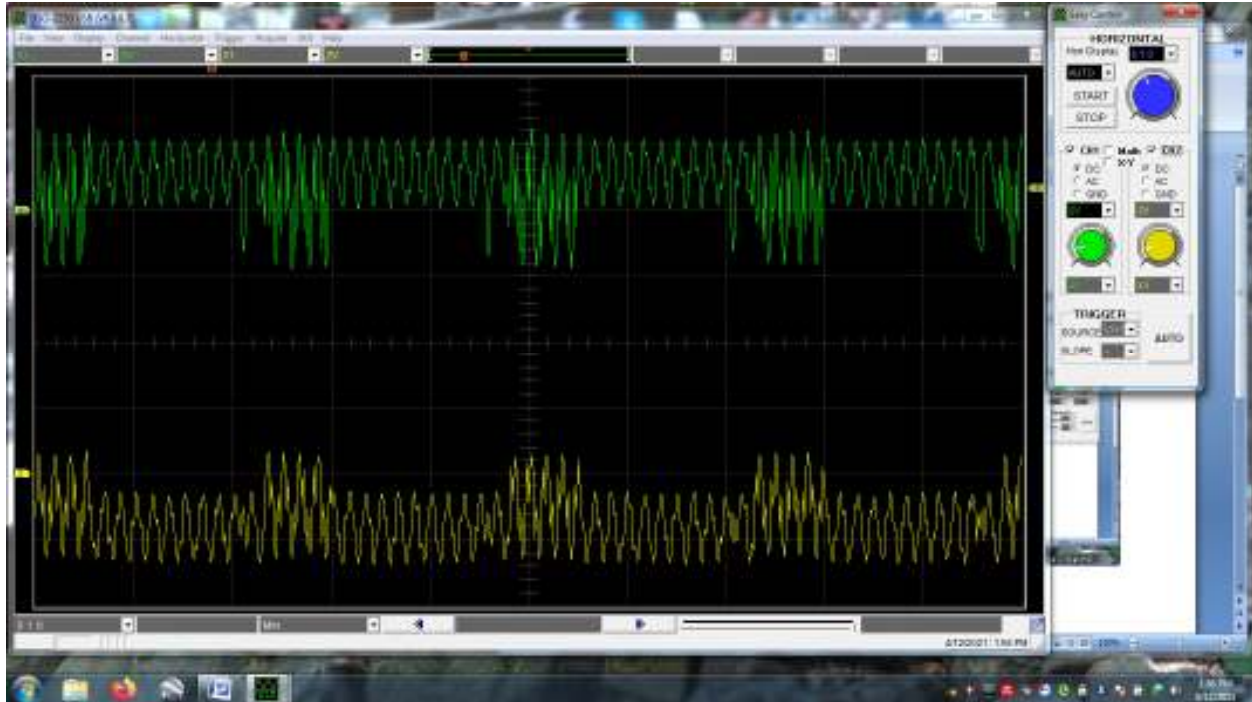
To be fair, I selected a battery powered test set up that could be powered from either a wall outlet, or a battery so that ground looping and hum issues would not be a finger pointer. From the insert above, the salient points are that this is a single pair of wires being probed by a dual trace digital scope. Both AC power and battery power were used in the testing to verify that no possibility for ground looping or insertion of aberrant signals in to the system could be a gremlin and lie to me.

This signal is supposed to be a positive offset DC bias of 14 Volts DC with ping inquiries and answers back from the field devices. A negative offset on the black wire is a mirror image of what should have been seen. What we got to our surprise was this 60 Hertz hum filled picture that totally obscures the DC offset values.

This was a shocker (pun intended) to all of us, especially the fire alarm technician who was working the wires with sweaty hands. What we were expecting to see was a screen full of R.F. carrier obliterating the alarm signals but nope.

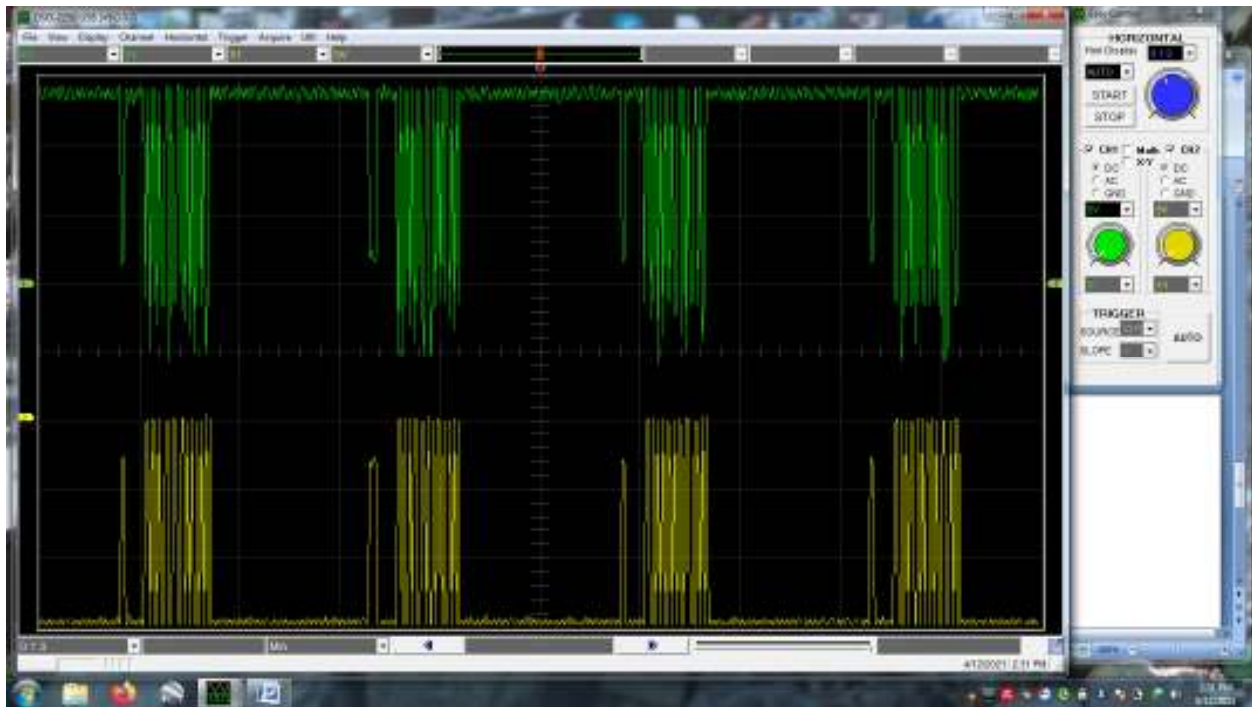
What we should have seen rather than this above monster hum was a very clean and explainable picture shot from a loop on one floor down from the target problem child. Clean DC offsets and clean ping requests are clearly visible.

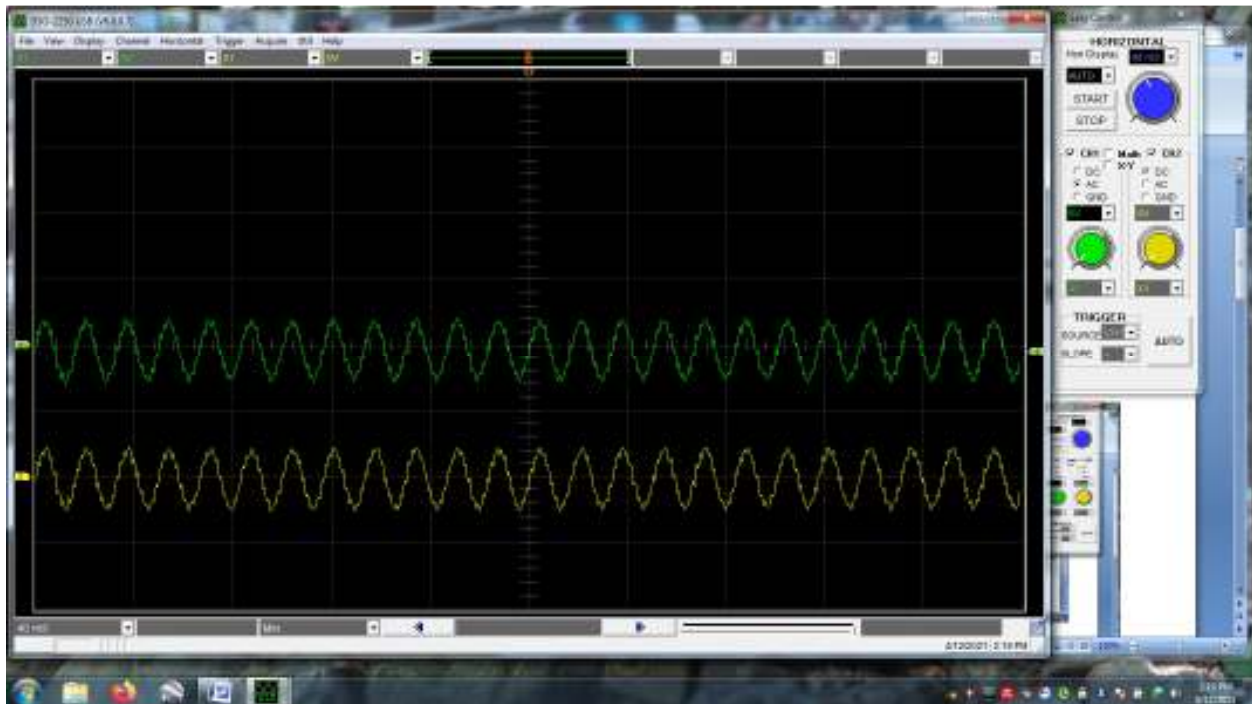
To insure that the visual results were fair and honest, multiple methods and configurations of sample were made and taken. We removed the loop from the controller and found the wiring to present a quite clean signal picture. Additional testing with the problem child loop disconnected from the controller also yielded a massive hum.

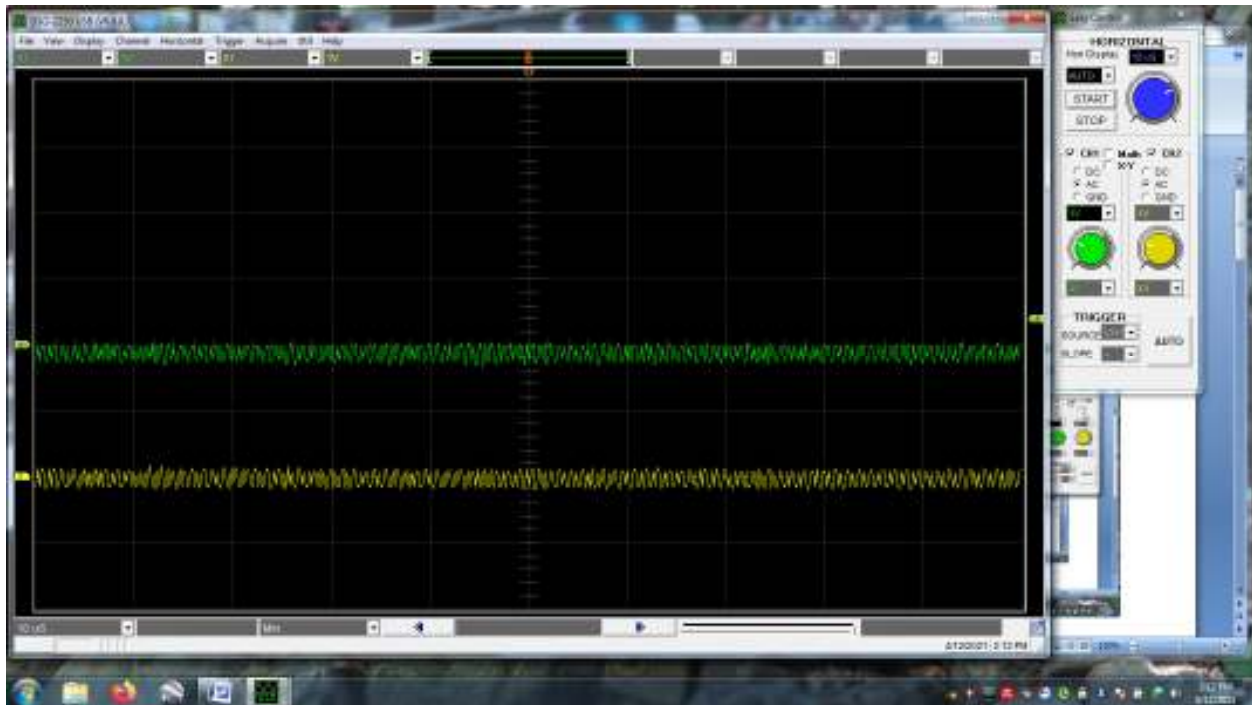
With detectors on the loop, I did not want to energize the system with a precision ammeter to investigate the possibility of a low level wiring short or other issue as I did not want to blow up any of the devices. Loops on the properly operating floors when disconnected from the controller yielded what we all expected which was very low noise results.

The addition of the R.F. carrier was just the straw that broke the camel's back. The R.F. combined with this gruesome hum was enough to randomly trip the alarm controller in to believing that the data on the line was wrong or corrupt so the response was to go in to full blown alarm or show a trouble when ever it felt like it.

I was informed by the alarm company that the problem was traced to a "wire problem" in the problem loop. How very specific.
