DIVIDE AND CONQUER

The Smoking Power Divider:

AN ARTICLE

GARY A. MINKER

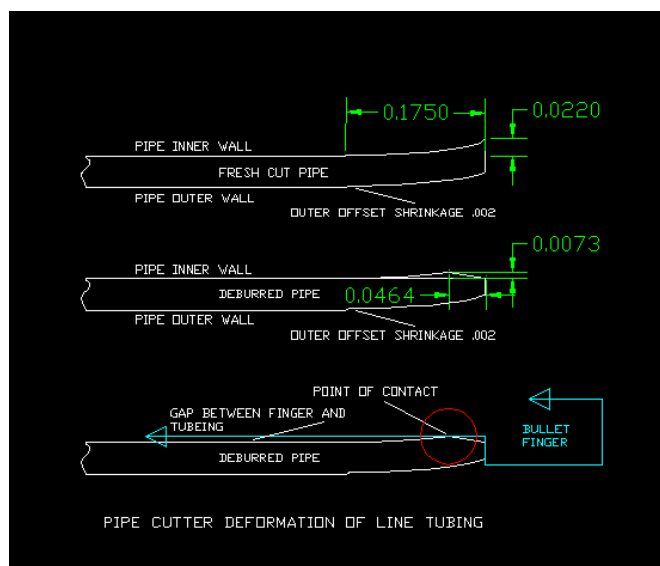
FIGURE 1:

This failure was brought on by a fabrication error. The fire started in a short cut section of pipe that jumped from the main vertical trunk feeder sideways, across the tower face to the Power Divider input between an elbow and a Tee section. The outer portion of this cut section was divine looking. It was beautifully polished and cleaned with a pristinely soldered pair of flanges crowning both ends.

The inner conductor was another story. I refer to another article about using a pipe cutter on inner conductors. <http://www.radioworksrfconsulting.com/pipecuttr.doc>

Figure 1 shows three actual measurements of different types of cut-off wheels and techniques of cutting. The inner conductor was cut on both ends with a pipe cutter, and the poor connection on the one end was worse than the other end and it simply burned the bullet fingers off from the extremely concentrated points of contact from the rolled tubing edge, current, and lack of sufficient heat dissipation. Figure 2 shows an actual Optical Comparator shadow image of a wheel cut inner end highlighting the deformation of the end of the tubing. Pipe cutters is an extremely

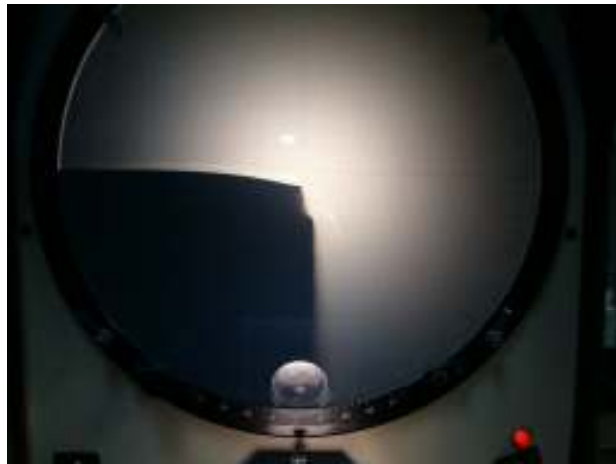
FIGURE 2:

controversial subject, but time and time again with inadequate filing or de-burring, the use of a pipe cutter on inner conductors has proven to be the source of line, bullet, and component failures. One end of the horizontal cut piece survived to be a witness and the pipe cutter roll pinch was so severe it was clearly visible to the naked eye.
