A Simple Careless Act:

AN ARTICLE
BY
GARY A. MINKER
Gary@RadioWorksRFConsulting.com
www.RadioWorksRFConsulting.com
561-346-8494

The Official Diagnosis:

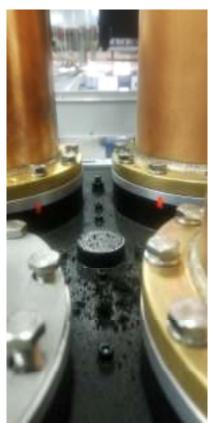
The primary damage to this system appears to be caused by the failure of the bullet coupler joint between the output of the impedance transformation 50 to 75 ohm section and the ascending elbow toward the system gas barrier where the line exits the transmitter room.

This joint failed due to unknown reasons which may have included a wrong type of bullet, forceful/negligent assembly which damaged the transformer and/or bullet, or simple greasy fingers on the bullet or insulator. The cause will not be discernable due to the severe heating of the joint resulting in the incineration of the supporting Teflon insulator and related bullet. The heat and soot from the incineration of this insulator and bullet caused soot to permeate the line system downstream toward the gas barrier some 16 feet away. No further heating was observed in this direction though soot contamination was present on the input face of the gas barrier.

The gas barrier was removed for cleaning and the spring tension of the output of the barrier was observed to be insufficient for continued proper operation and the recommendation to replace the gas barrier was made while repairing the old unit for later re-use.

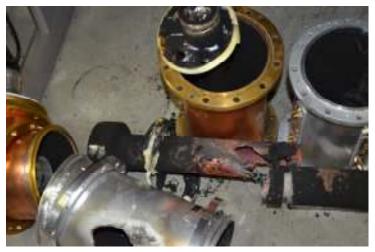
With the output of the transformer destroyed, multiple cascaded 1/4 wave failures melted, annealed and burned 6 locations traveling 65 feet upstream toward the transmitters and the coaxial switch. Having lost the load from these multiple burn throughs in the line, the coaxial switch exploded internally with sufficient force to expel a large quantity of soot out of the un-

used portal.

Having lost the coaxial switch, the in line tuner attached to the output of the final hybrid melted sufficiently to leave a pile of molten Aluminum on the floor and destroy the R.F. monitoring coax cables along with the switch operation cable that were attached to it.

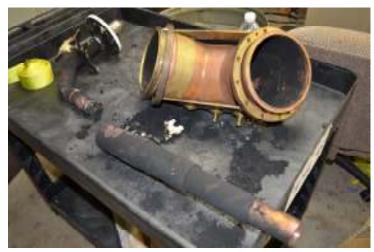
Parts that are designed to look pretty on AutoCAD may indeed look pretty when installed but the actual work of installing them between 2 fixed, rigid, and immovable objects is cause for not only concern but IF you actually do get the parts to fit without damaging them, you can pretty much forget ever taking them apart for service, maintenance or heaven

forbid, a repair. This is the situation with this installation. Filters and plumbing were situated in such a way that only with complete disassembly of entire sub-systems would allow for the removal of some components. The entire concept of the "service loop" escaped the designer who should be forced to work in the field before ever being allowed to design another facility layout.
