# Two-Way-Radio Noise Floor

AN ARTICLE

GARY A. MINKER

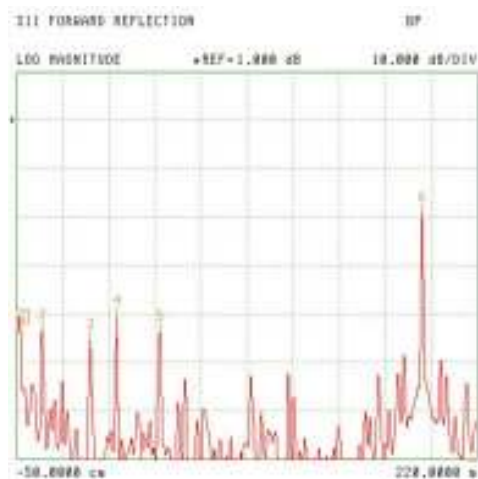
The dummy load and short test are also revealing but your trusted Line Sweeper is wrinkling his nose and things just don't seem right. The purple line is the insertion loss of the line. The upstairs band splitter is removed and a dummy load is attached to the trunk line Type "N" connector. This value is divided by 2 since the insertion loss is a one way trip thing and the Vector Network Analyzer is a bi-directional measurement. Even for 7/8" Heliac type product 7dB seems a bit high for a value in the 450 band. The line is sort of linear in its loss curve but the number is a bit high. The #38 Bible catalog says .8db a hundred at 450mc. A total line length of just over 500 feet should not be more than 6dB. The next nose wrinkling item is the red data Return Loss. A precision load on the end of the line (given the high number of dents) looks sort of un-normal with the average value of "only" 25dB. A 40db load, with 6dB of line loss comes up with the dreaded phrase, "The response to stimulus is not as expected".

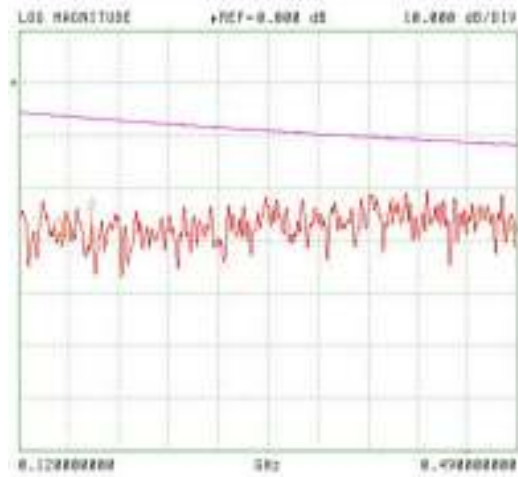
More troubleshooting commences. The decision is made to remove the 7/8" brass connector and check for water. The crew sends down some photos of Tadpoles swimming in the connector and the foam on the Heliac is so wet it is crumbling. This is Foam filled product and water in the connector usually means water slithered WAAAYY down the cable but the Time Domain said no. The cable is cut back 12 crummy inches and to everyone's surprise, the line is clean. The Analyzer was right, the connector was cleaned within an inch of reality and re-installed.

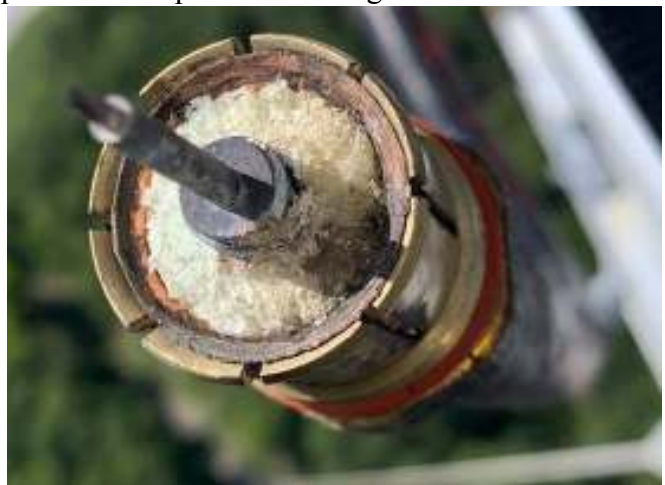
The testing results are much better so we move on to checking the band splitter. The female connectors on the splitter look ok but the possibility of some water seepage into the input connector from the obvious failure to tape and snot does exist. Dummy loading of the band splitter was marvelous.

With the previous Insertion Loss purple trace still visible, the VHF / UHF band splitter shows the crossover hump right in the middle around 310mc as it should be. Good quality loads on the output ports of the splitter show the target frequency areas and things look pretty good considering the nearly 7dB of Heliac insertion loss. OK, so far we have cleared one nasty problem. Testing moves on to re-attaching the VHF antenna. This reveals a properly shaped Return Loss of the antenna and the mood lightens up as submarine sandwiches are eaten.

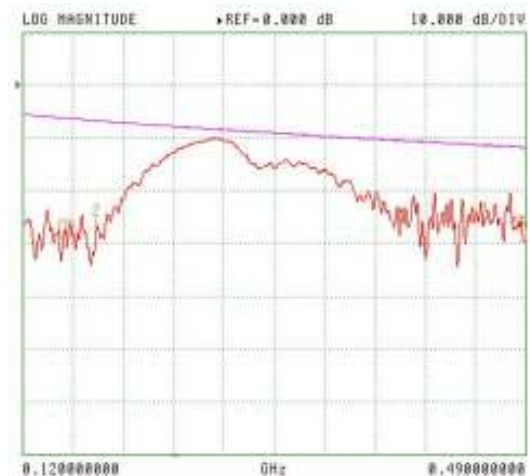
The VHF antenna has a great shape and the crowd goes wild. Amidst the cheering with the UHF port screwed to the still un-terminated cable from the antenna, we decide to test the UHF jumper with a dummy load. Comparing the purple to the red, the jumper seemingly responds correctly for insertion loss addition and load, but whoa to us. This is where we get fooled again. Testing this jumper with the top mounted band splitter, its loss (though small) and the high value loss of the trunk line, this all seemed fine until we try to look at the UHF antenna.

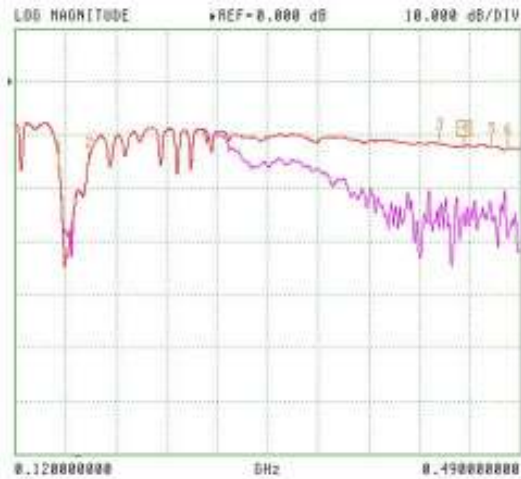
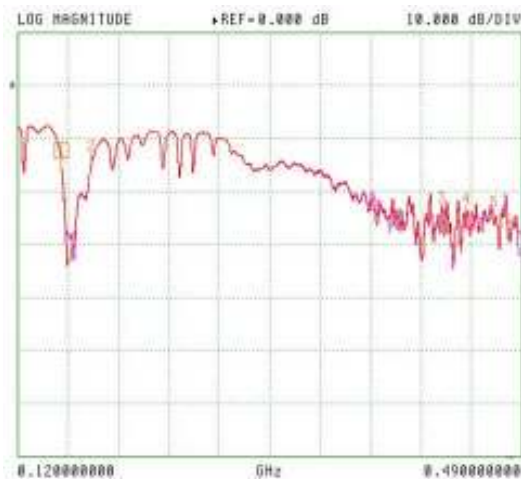
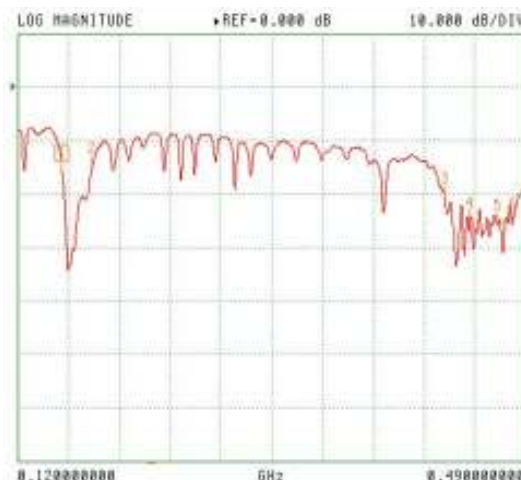
The UHF antenna looked alarmingly like the dummy load on the end of the UHF jumper. The decision is made to bring the antenna down to the ground. Once on the ground, the antenna tested as good.

(confusing) This confounded pretty much everyone so we decided that though the jumper appeared to test well, the losses must be hiding the band shape of the antenna so a new jumper went up the tower along with the freshly tested antenna. With just a few minutes to install the antenna and jumper, great joy was found when suddenly both antennas could now be seen. The correct band widths appeared, and the system came back to life.
