## JUST WHEN YOU THINK YOU'VE SEEN IT ALL

Microwave path failure at it's finest

By Gary A. Minker

June, 2017

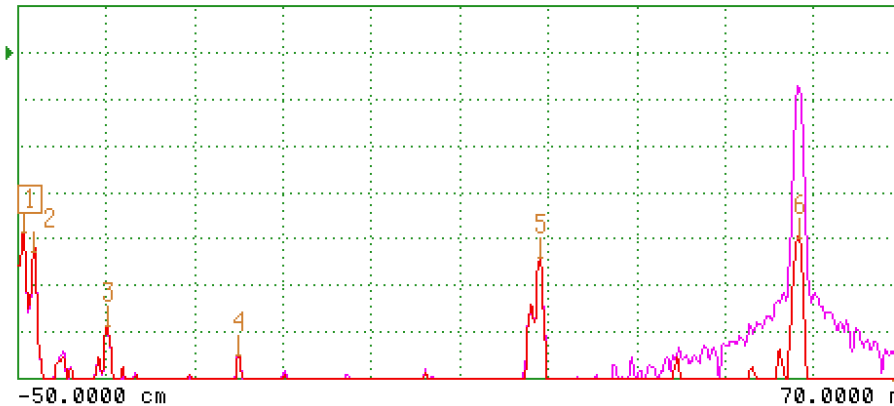
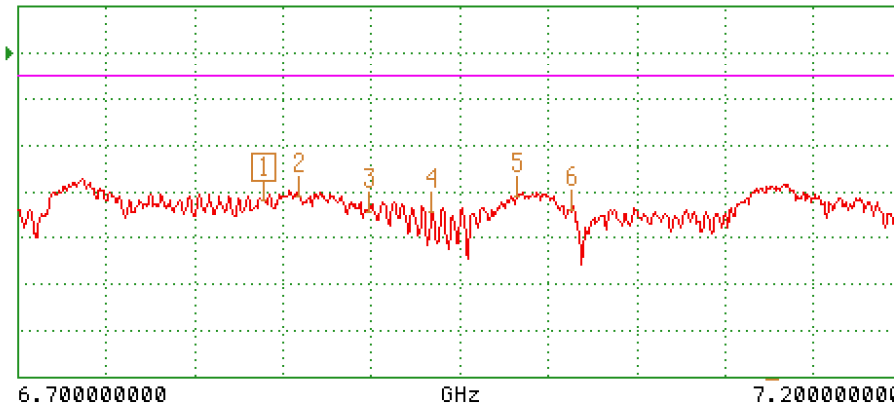
Up the tower goes the replacement feed horn. After nearly a hour of trying to snap corroded hardware and 2 cans of Kroil, the old feed was out and the replacement was installed. In the words of Gomer Pile, shazam and goolllee, the result on the analyzer was sheer joy. (see figure 3) This data trace is a live look at the broken feed horn.
