# Intermittant Fire Alarm

AN ARTICLE

GARY A. MINKER

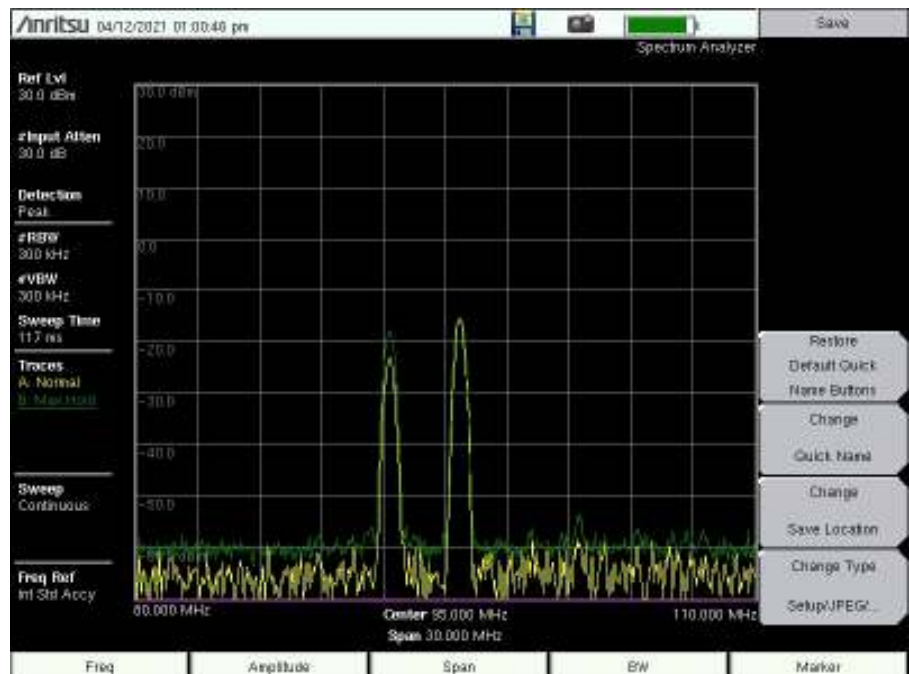
With the Spectral evaluations stored in the memory of the Analyzer, we had agreed that additional testing would be performed on the actual wiring of the fire alarm through invasive scope probe methods with a color digital Oscilloscope. The first sample location was in an electrical room on the upper floor in question. From here we could directly access the home run to the master loop controller as well as the two loops of trigger devices such as smoke detectors.

This fire alarm is a new technology one pair digital system that both powers the detectors and communicates with them on the same pair. While my feelings on the approved choice of wire was askew from the other participants, un-shielded solid, single twisted pair 16 gauge in a vinyl jacket and encased in conduit might not have been my first choice but I digress.

Everyone was expecting to see this massive smear of R.F. carrier on the screen of the Oscilloscope. I have to admit, I was half expecting this also but when we got started connecting to the system, The picture of the grinning idiot was not what we expected.
