DON'T DO THAT:

The Great Flood

By: Gary Minker

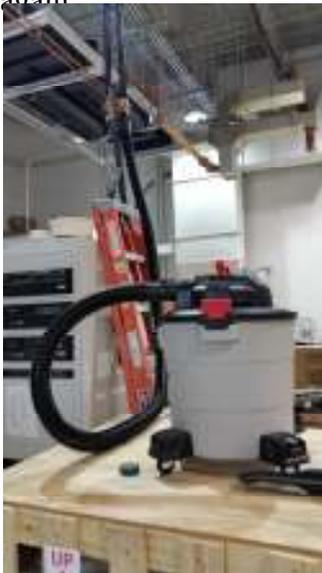
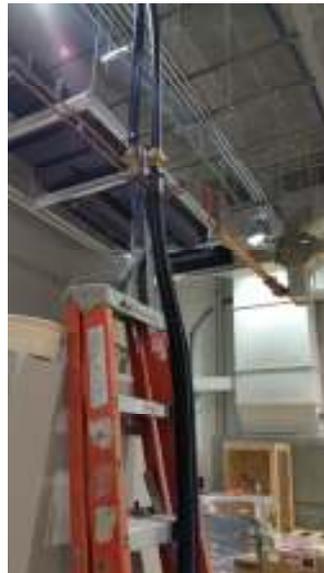
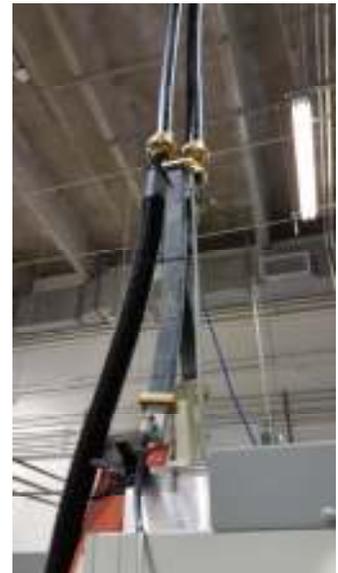
A search for a source of warm dry highly pressurized air was set upon around the facility and we found a shiny new shop vacuum. The climber installed a sock with tape to the top of the line and covered it with a bucket to insure that rain was not our enemy, along with a hose connection made to the line down below. The vacuum was set up to blow warm air through the line ,and after three hours of this treatment. On the three hour mark, was tested for insertion loss once again

Happily, a new and improved value to 23dB was seen, and the warm purge continued for another four hours. With fingers crossed and the senior staff still in frightened disbelief that I could be related to Lazarus of the R.F. world, the line popped up with only 4.3dB greater loss than the factory specification for brand new line and this was still not fully dried out.

This line is Down Hard. Infinite insertion loss and no audio traverses through the blow hole like an old tug boat to the engine room. The collective decides that there could likely be up to a half gallon of water in the line from the magnitude of the sloshing and we decide to strip a few inches of Vinyl off the low spot and with pressure on the line to keep chips from entering the line, drill a very careful 1/32" hole in the bottom of a high spot annular ridge. With 5 PSI on the line, I could hear the shriek of joy from the climber hanging in his harness when the suspected half gallon of water came spitting out in to his lap. After about 4 minutes of hurricane force leakage, the line stopped peeing and started to just hiss. We applied a suitable hole repair to the holy spot and went on to continue testing.

In microwave 7GHz service just 1 vaporized CC of water can bring a good system nearly to its knees. With the majority of the blockage now gone, I could communicate with the climber through the Elliptical and with radio in hand a new insertion loss test revealed about 50dB of insertion loss which was a step in the right direction from infinitely toasted.

With a savings of over \$23,000.00 in the bag as compared to replacing the line and being off the air playing smart phone videos for a month while waiting for a new spool and connectors, a Nitrogen purge protocol was initiated that I have designed. This protocol continued for a week with a 1.5 PSI popper valve at the top of the line to continuously bleed Nitrogen and moisture out of the system. Yes Matilda, we still have a leak to find but that can be done once the line is dry and time is on our side.

With a week of purging at 1.5 nominal PSI using industrial grade Nitrogen from a Liquid Dewar and precision regulator, the line returned exactly to factory specifications and the leak was found. Pinched gaskets can take years to become problematic.
